# *Hidden Valley Property Inspection*

## Property Inspection Report

1776 E. Constitution Avenue, Anytown, UT 84321  
Inspection prepared for: Joe & Jane Homebuyer  
Date of Inspection: 11/10/2017 Time: 8:50 am  
Age of Home: Built 2016 Size: 6,580sq ft. (not verified - public record)  
Weather: 38 degrees, clear

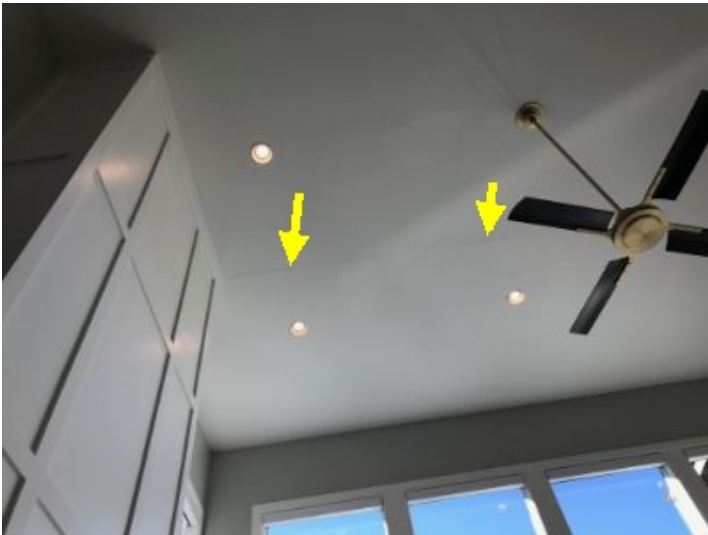
Ceiling cracks observed at sheetrock seams, new construction settling.

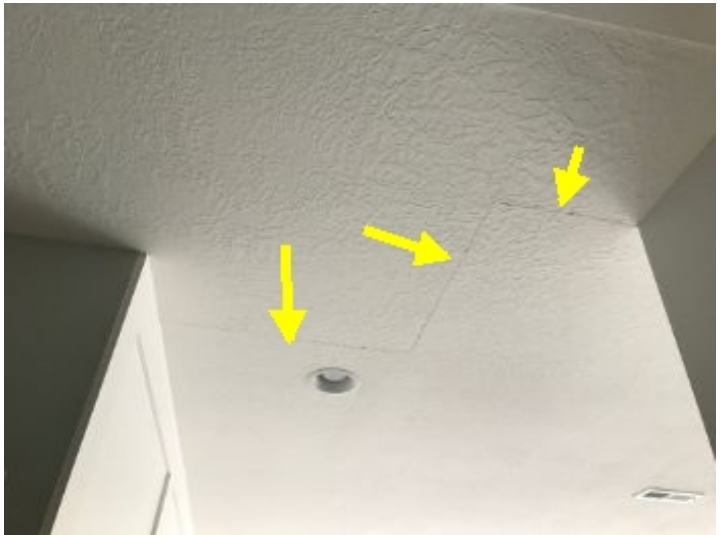
Ceiling cracks observed at sheetrock seams, new construction settling.

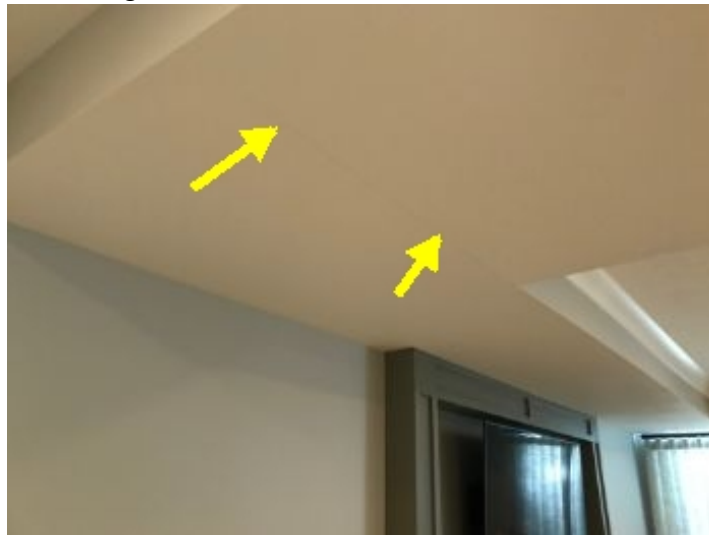
Ceiling cracks observed at sheetrock seams, new construction settling.

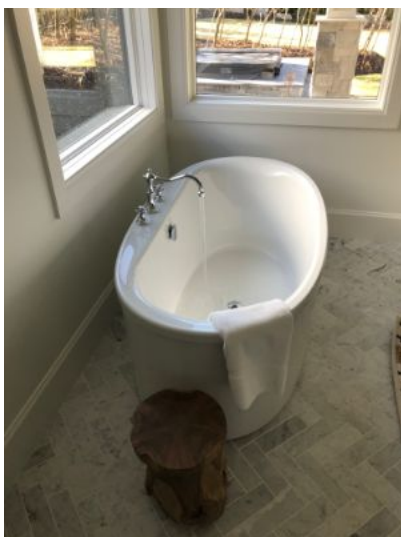
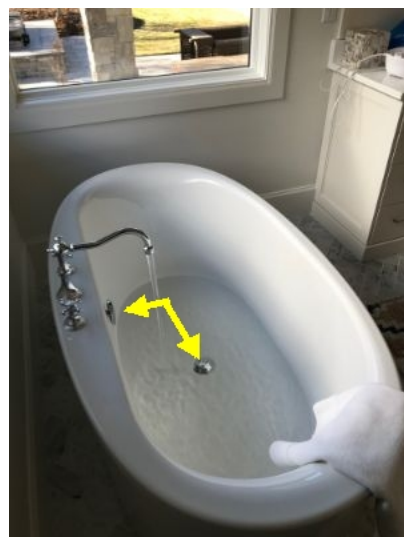
- Master bath Stopper and vent is loose/inoperable.

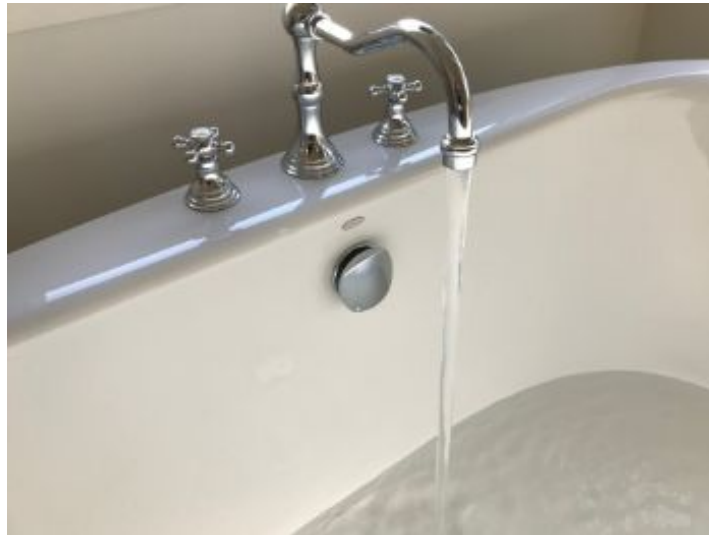
Master bath Stopper and vent is loose/inoperable.

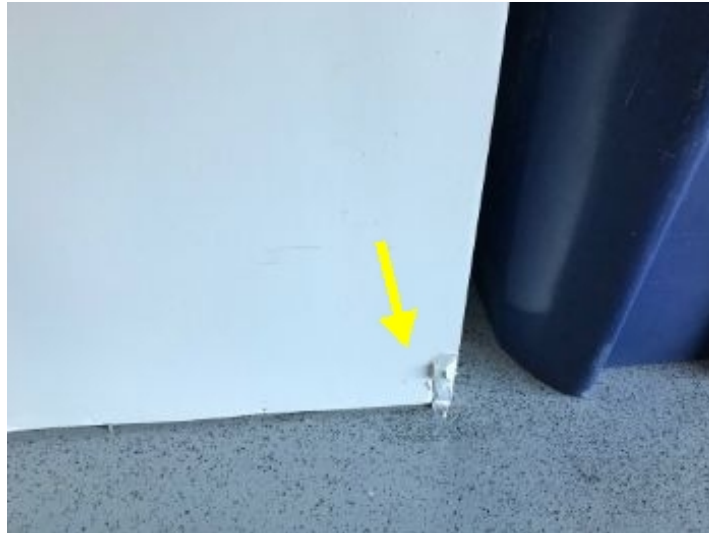
Minor damage to corner bead in garage. Does not appear to have been fully skim coated due to bent lower section.

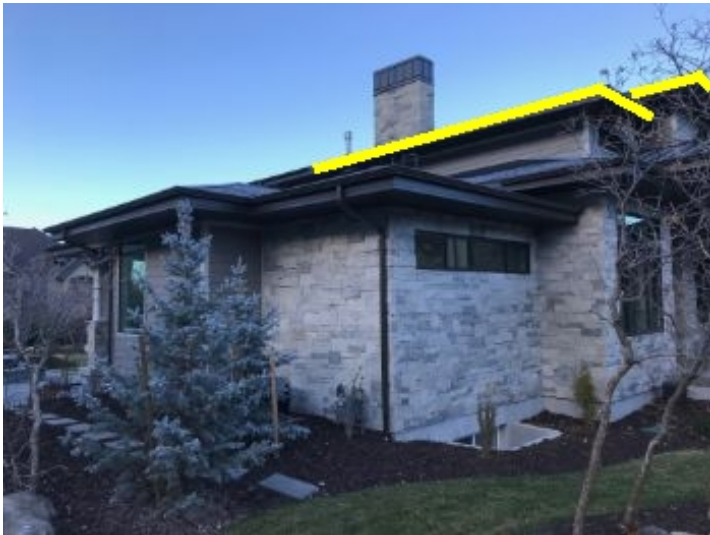
Partial gutters - Upper eaves. North facing. These areas will be prone to ice buildup as no sunlight will hit this area. Full installation recommended to keep water away from upper siding structure. Upper eaves in line with lower eaves. Water runoff to driveway will be problematic in future. Water can weaken the foundation and deteriorate the siding and be very dangerous on areas of north facing driveways that do not get direct sunlight. Be sure to install splash blocks or extensions to carry water away, and keep water from areas such as driveways or walks where it can be an ice hazard in winter.

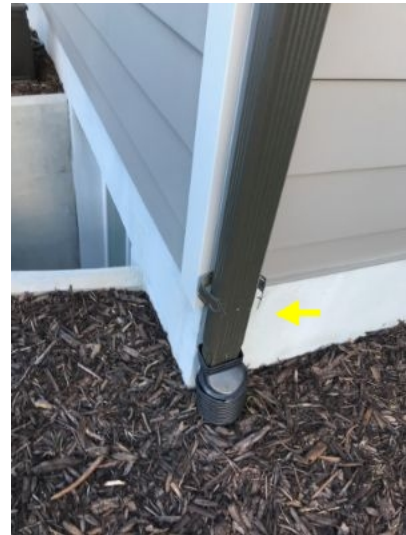
Downspouts pulling away from the house at SE rear; re-secure as needed.

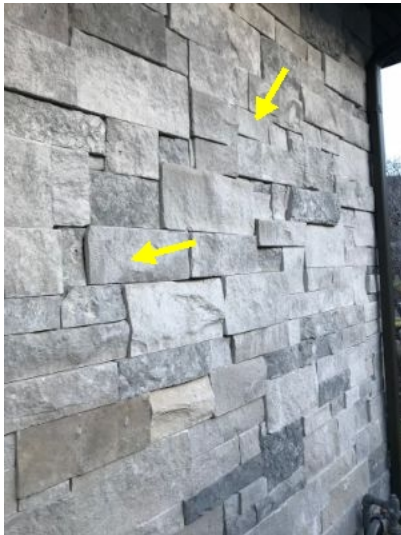
Several loose stones on siding.

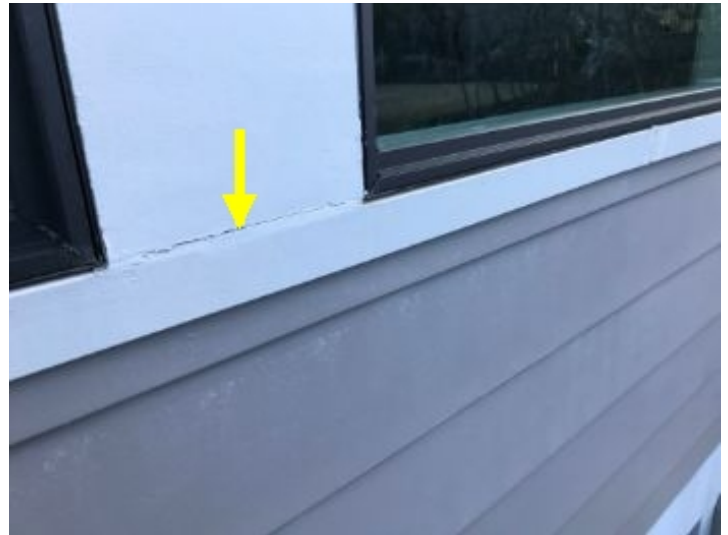
Caulk and seal all gaps, cracks and openings as part of routine yearly maintenance.

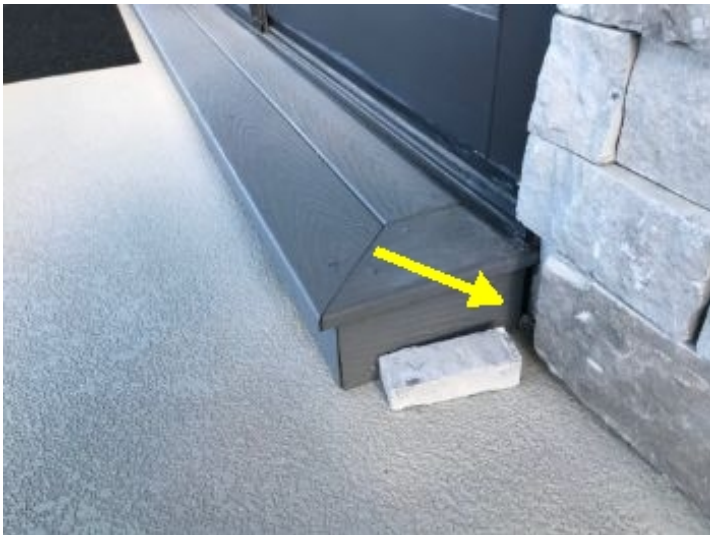
Several loose stones on siding.

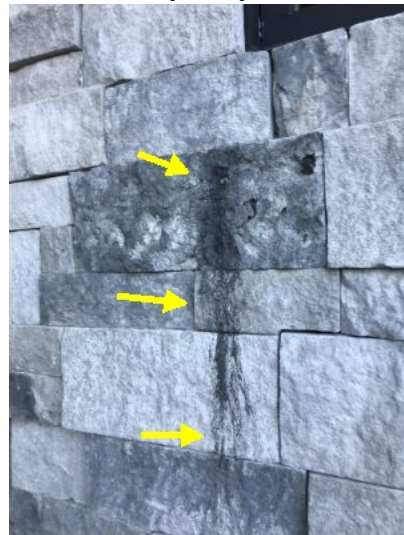
Several deteriorated stones on siding and mailbox. Eroding in place.

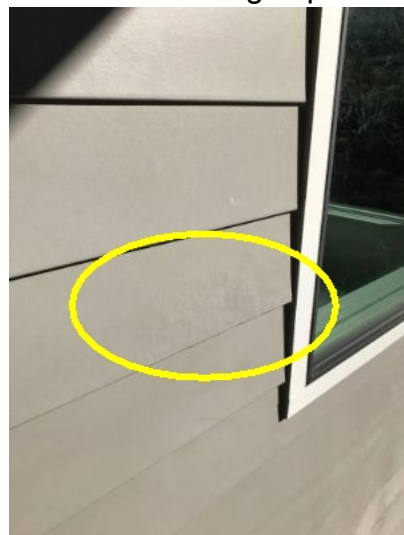
Defective section of hardi-board siding on SW corner by master patio.

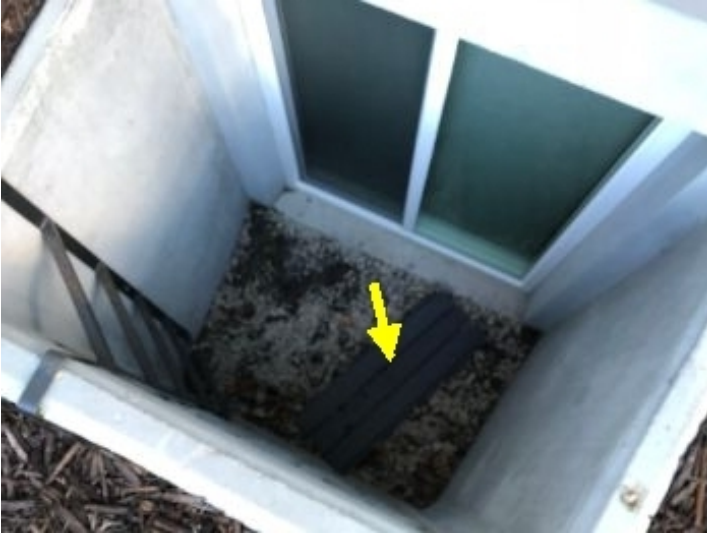
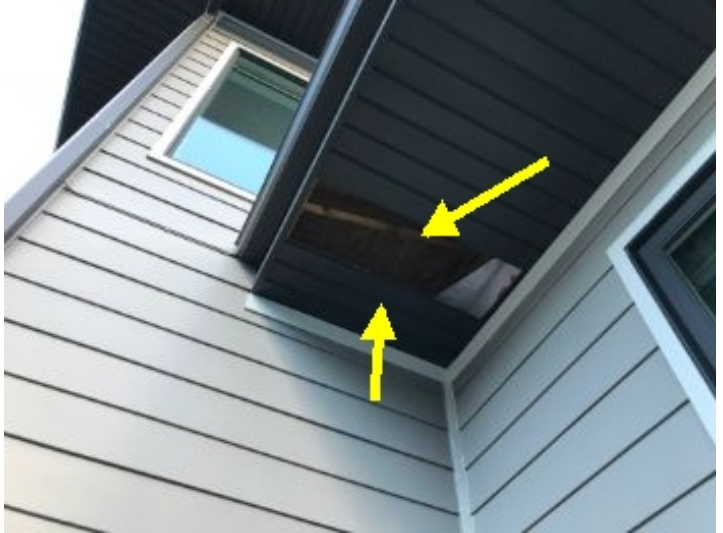
Loose section of soffit observed on South side, has fallen down into window well. Monitor all south areas periodically after strong south winds for any further sections that may become loose.

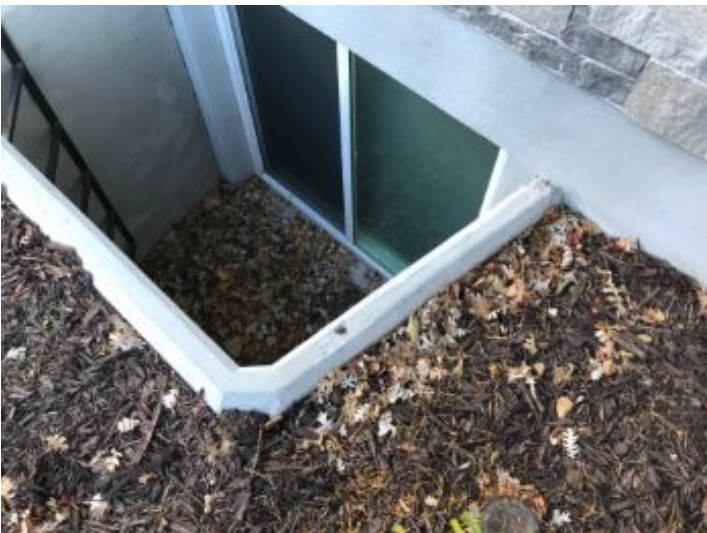
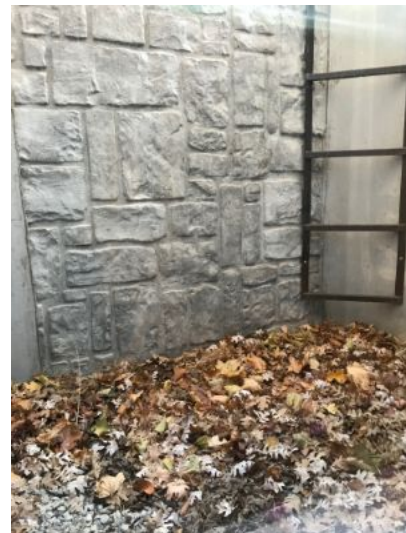
• Clean out window wells, debris and leaves near lip of cement foundation can prevent water from properly draining and divert water towards windows and foundation.

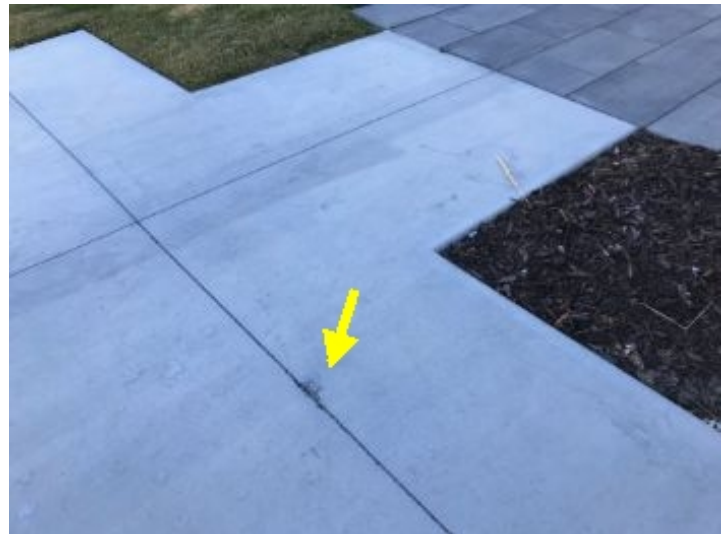
Cracking/Chipped areas observed at the concrete surfaces. Further deterioration will occur as water expands and contracts from freeze and thaw cycles. Recommend sealing the cracks to prolong the life of the concrete.

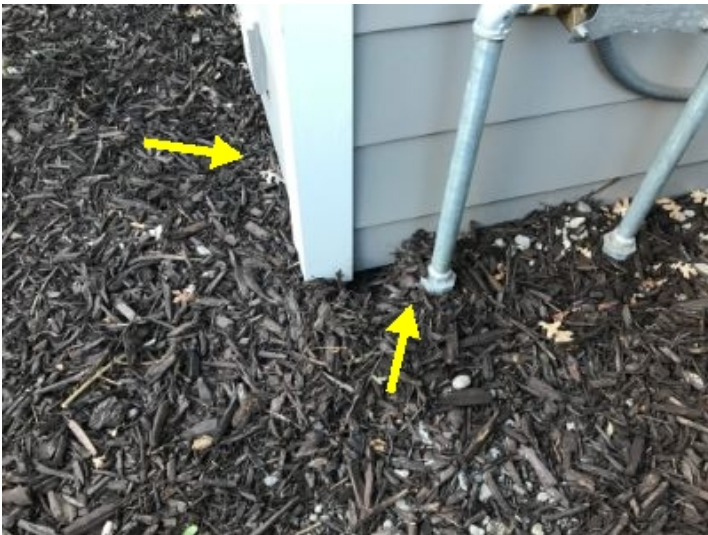
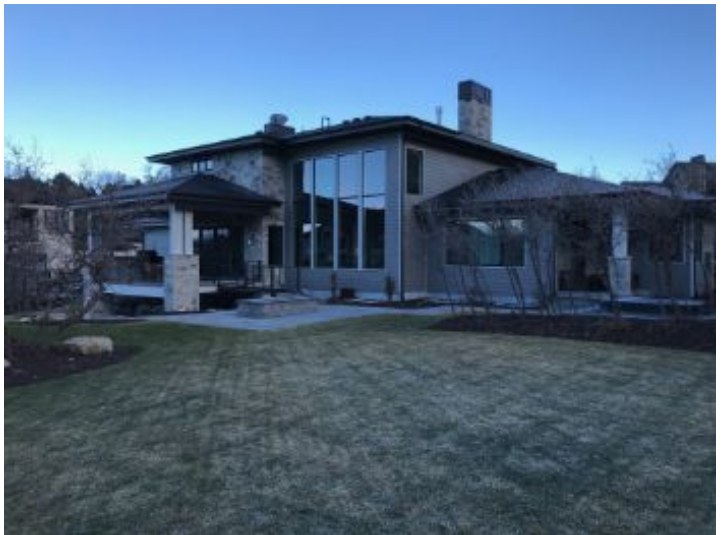
Keep bark away from composite siding to minimize moisture damage and pest issues.

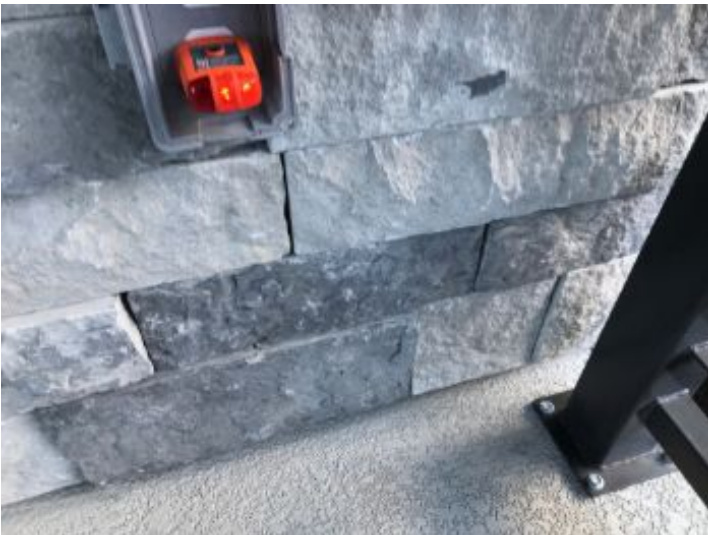
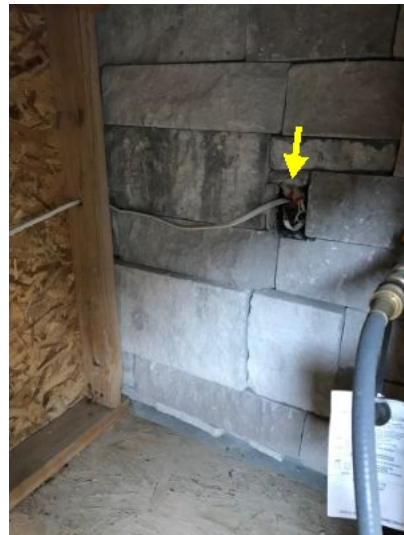
Junction box cover missing in patio kitchen area, no visible flashing or water sealant along end of counter top, water can run down siding and into electrical j-box. Add exterior grade cover as needed.

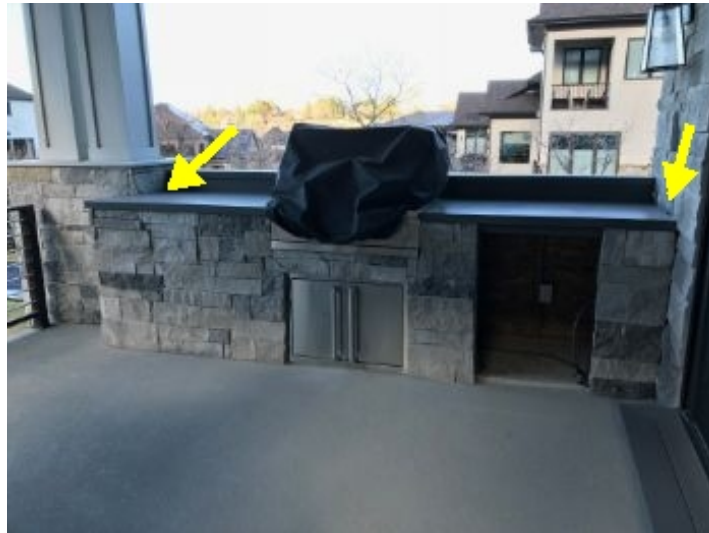
Junction box cover missing in patio kitchen area, no visible flashing or water sealant along end of counter top, water can run down siding and into electrical j-box. Add exterior grade cover as needed.

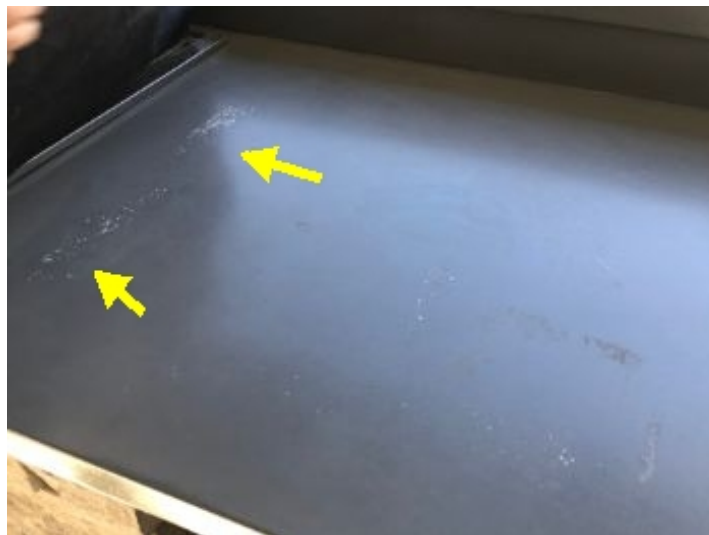
Cement counter top stain/paint is peeling from surface.
