# *Hidden Valley Property Inspection*

## Property Inspection Report

1776 E. Constitution Avenue, Anytown, UT 84321  
Inspection prepared for: Joe & Jane Homebuyer  
Date of Inspection: 11/10/2017 Time: 8:50 am  
Age of Home: Built 2016 Size: 6,580sq ft. (not verified - public record)  
Weather: 38 degrees, clear

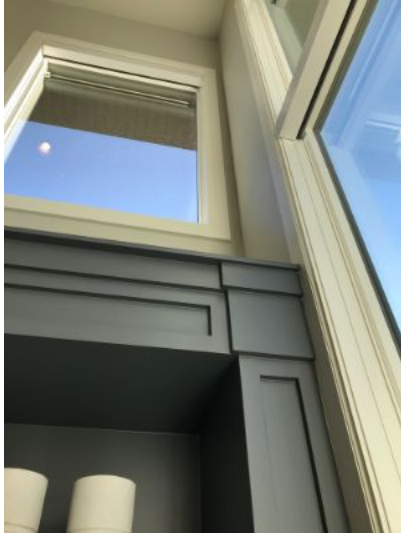
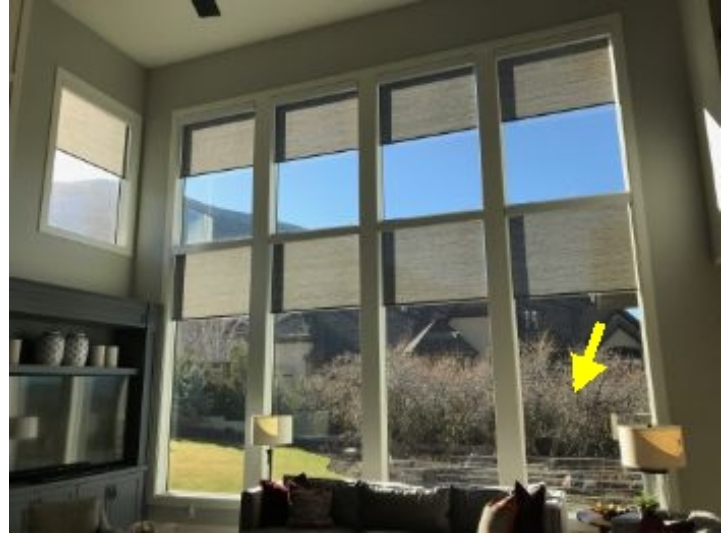
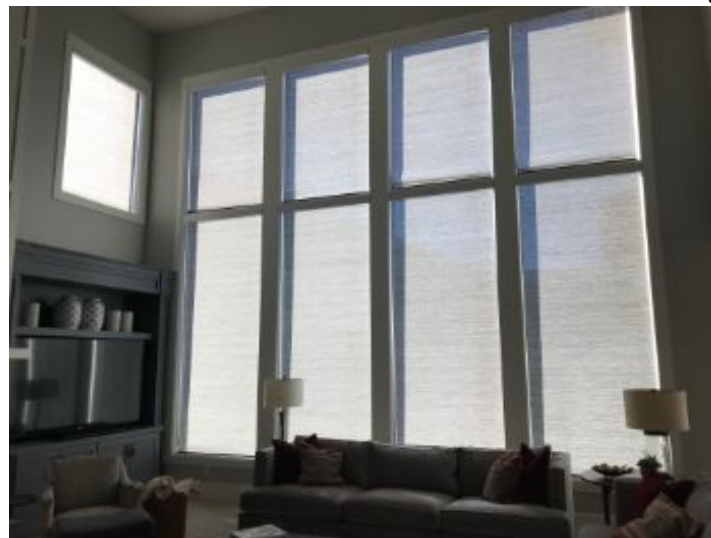
13. Window Condition

- Numerous areas where glass is etched/scratched on outside of large south windows.

Numerous areas where glass is etched/scratched on outside of large south windows.

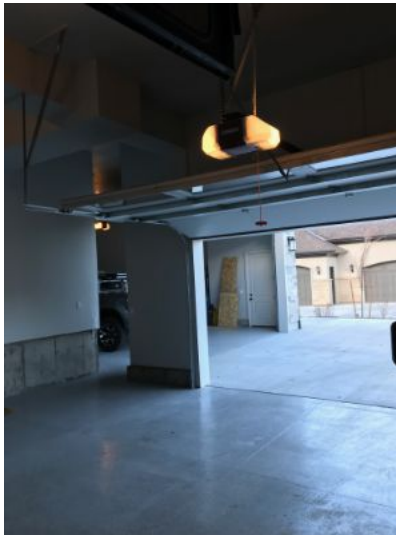
Minor damage to corner bead in garage. Does not appear to have been fully skim coated due to bent lower section.

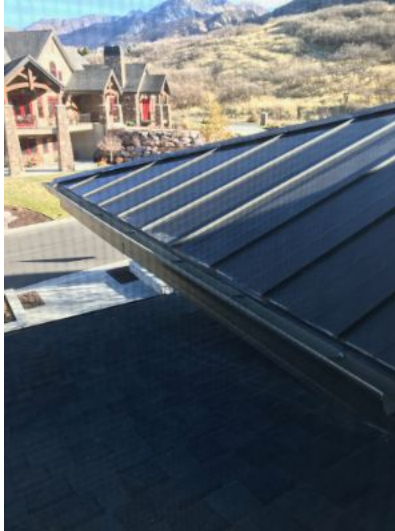
- Construction debris on roof areas, mortar from siding installation, trimmings from roofers. This debris can get into gutters and obstruct water flow to downspouts.
- Consider improving north facing eaves with heat cord to minimize ice buildup.

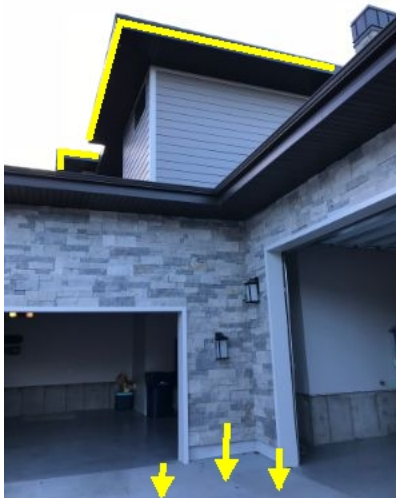
Partial gutters - Upper eaves. North facing. These areas will be prone to ice buildup as no sunlight will hit this area. Full installation recommended to keep water away from upper siding structure. Upper eaves in line with lower eaves. Water runoff to driveway will be problematic in future. Water can weaken the foundation and deteriorate the siding and be very dangerous on areas of north facing driveways that do not get direct sunlight. Be sure to install splash blocks or extensions to carry water away, and keep water from areas such as driveways or walks where it can be an ice hazard in winter.

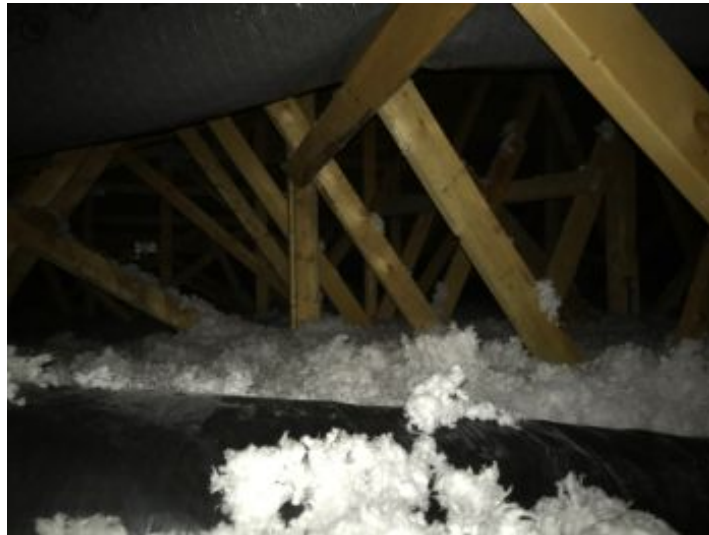
Materials: Loose fill insulation noted.  
 Depth: Insulation averages about 16-18 inches in depth. R-38.  
 Observations:  
 • Insulation appears adequate for this region of the country.

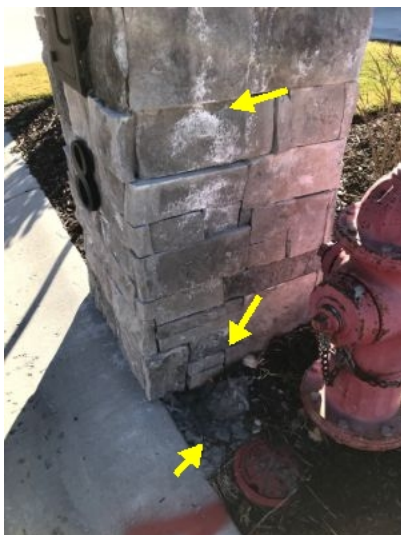
Several deteriorated stones on siding and mailbox. Eroding in place.

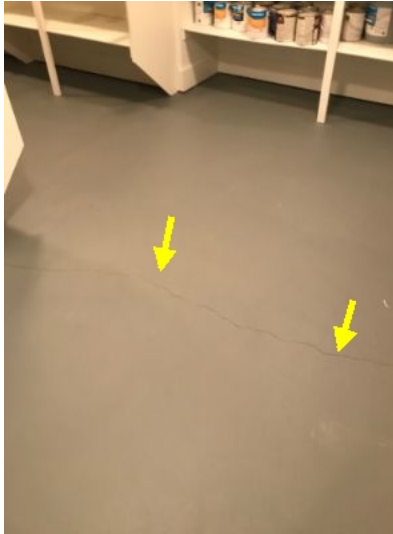
Common cracks noted.

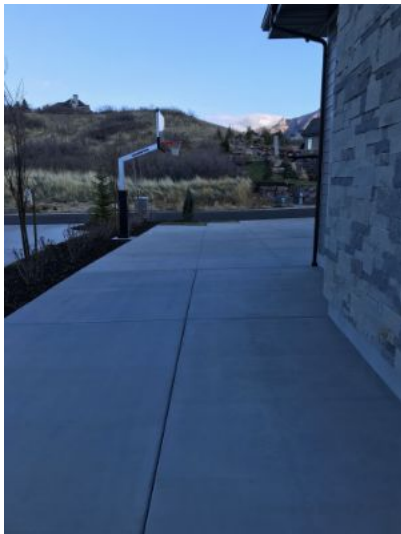
- Surface staining observed, rust colorations.
- Residual cement droppings noted on some slabs.

Cracking/Chipped areas observed at the concrete surfaces. Further deterioration will occur as water expands and contracts from freeze and thaw cycles. Recommend sealing the cracks to prolong the life of the concrete.
